TRANSPORTATION RESEARCH CENTER

ON-SITE AIR BAG FIRE INVESTIGATION

CASE NO. - 94-16
FLEET - PRIVATE VEHICLE
LOCATION - S [REDACTED], WISCONSIN
ACCIDENT DATE - [REDACTED] 1994

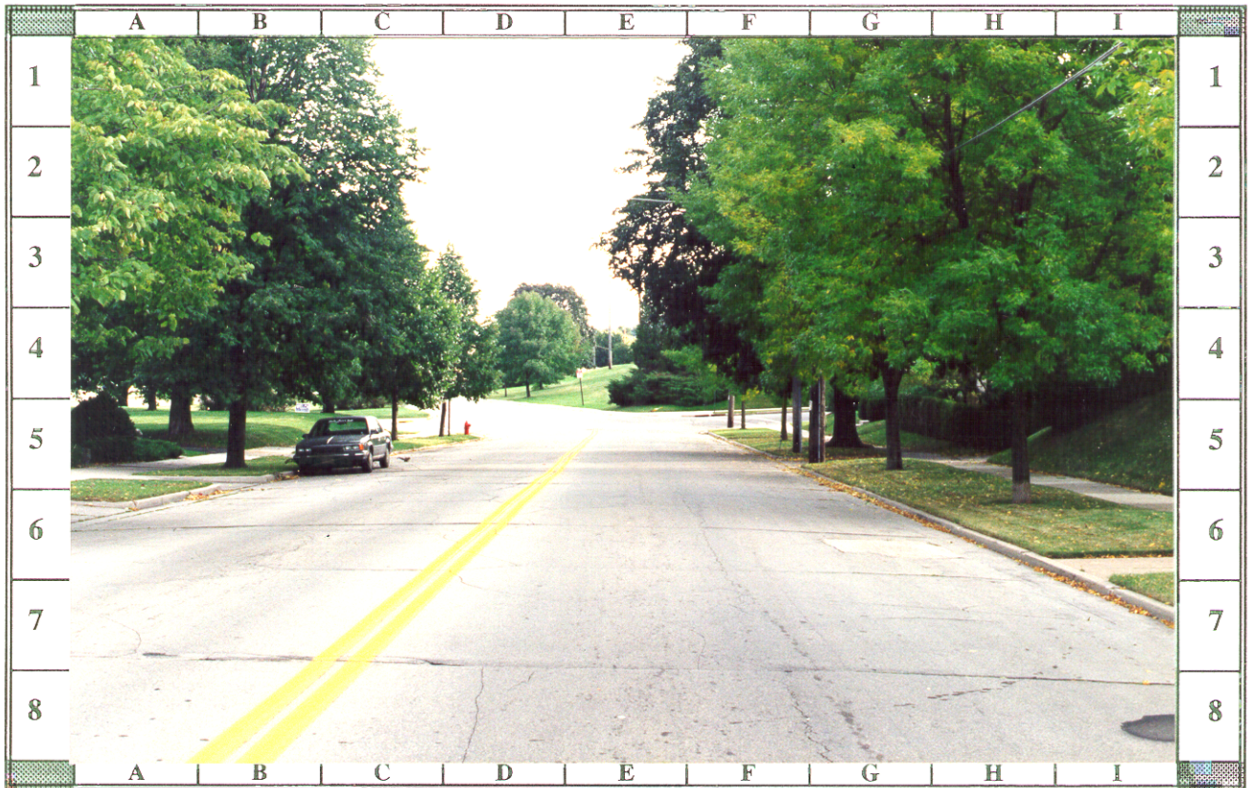
01 -- 1995 Plymouth Neon's southward downhill travel path approximately 65 meters north of intersection

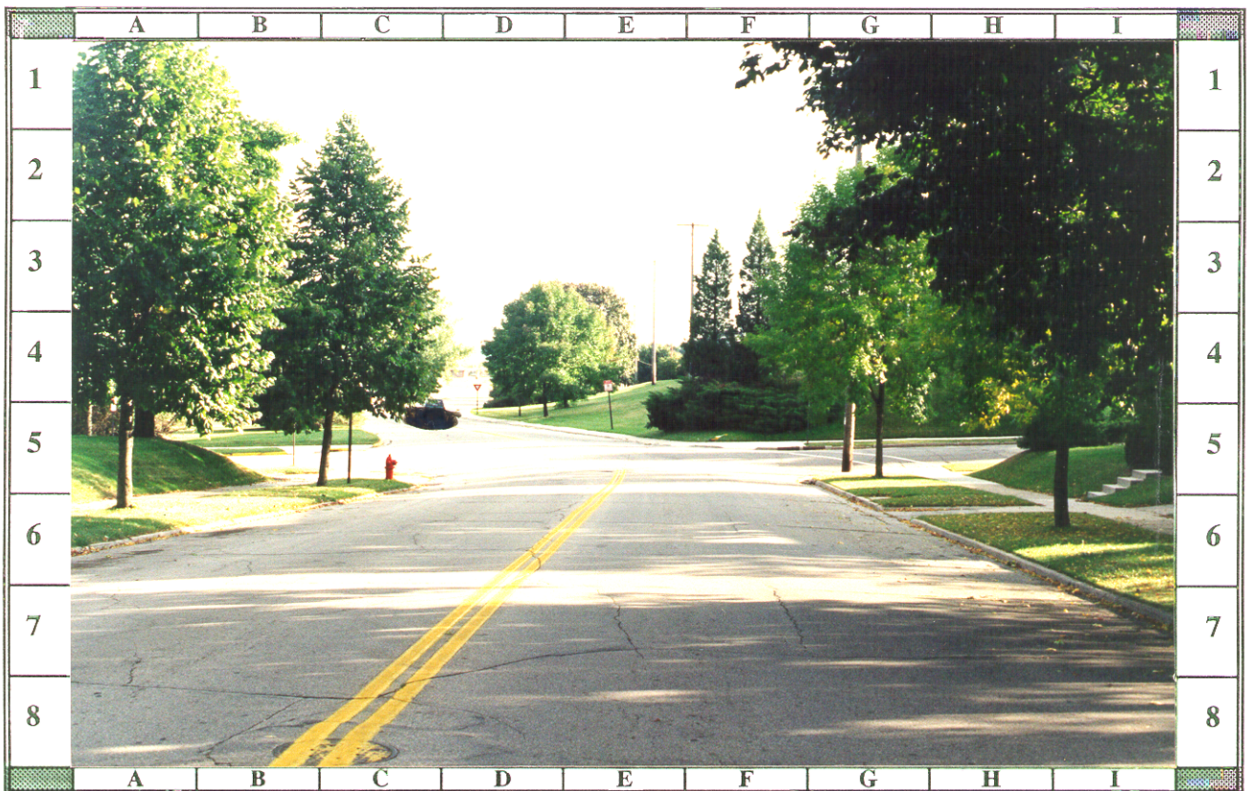
02 -- 1995 Plymouth Neon's southward downhill travel path approximately 25 meters north of intersection

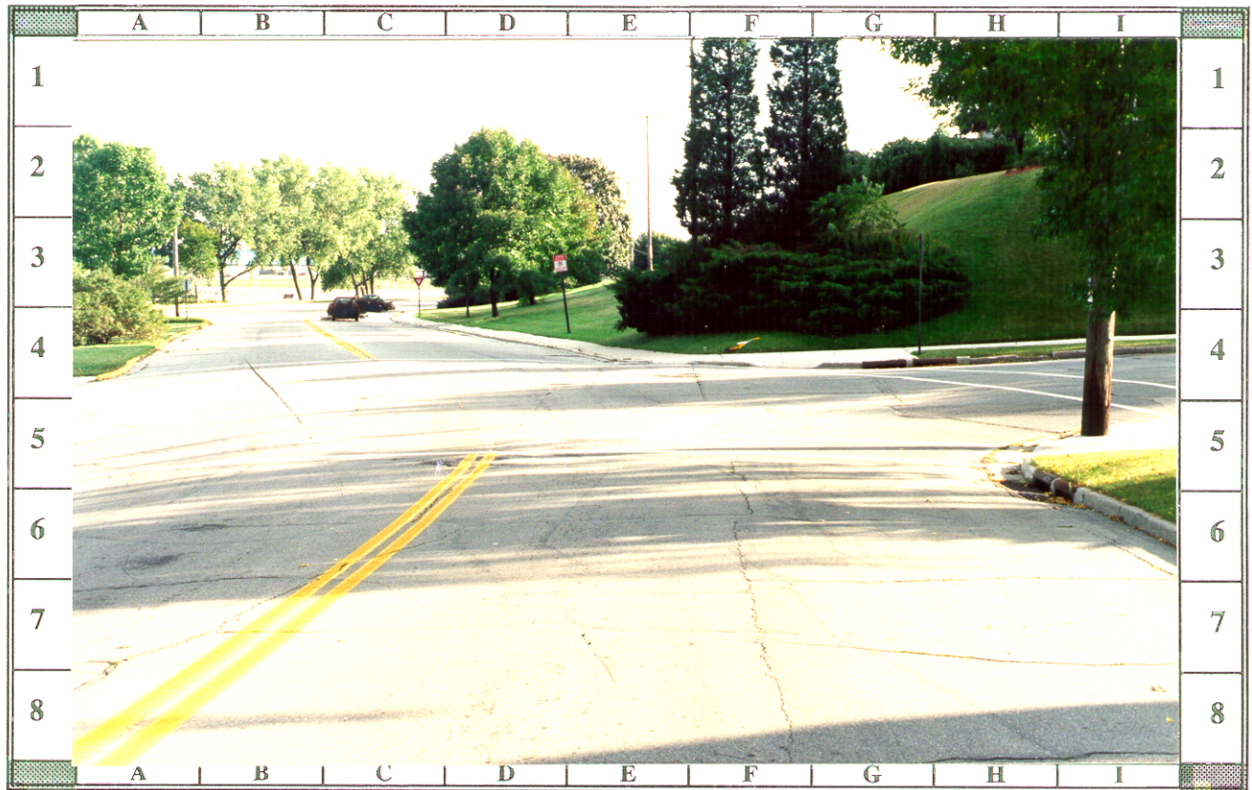
03 -- 1995 Plymouth Neon's southward downhill travel path just prior to intersection; NOTE: south leg angles south-southeast

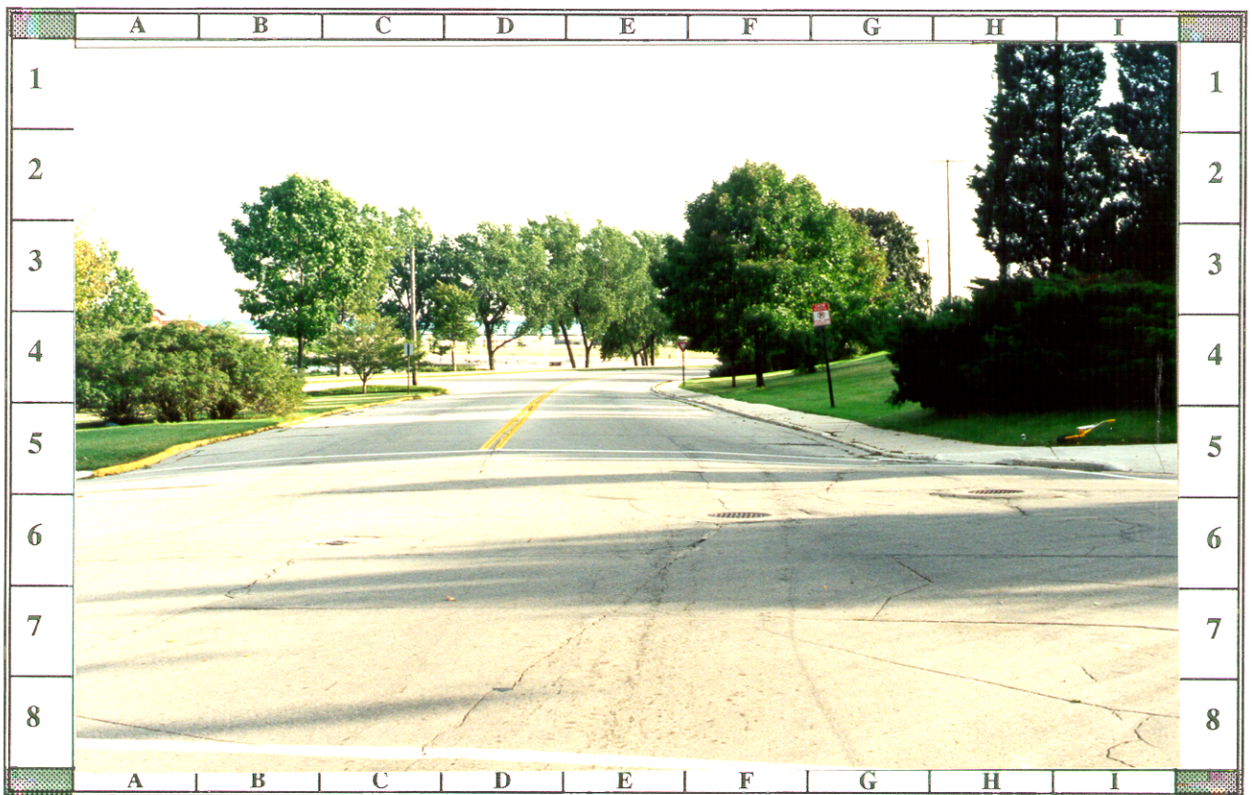
04 -- 1995 Plymouth Neon's south-southeastward downhill travel path ~ five meters north of initial impact with 1986 Dodge Omni

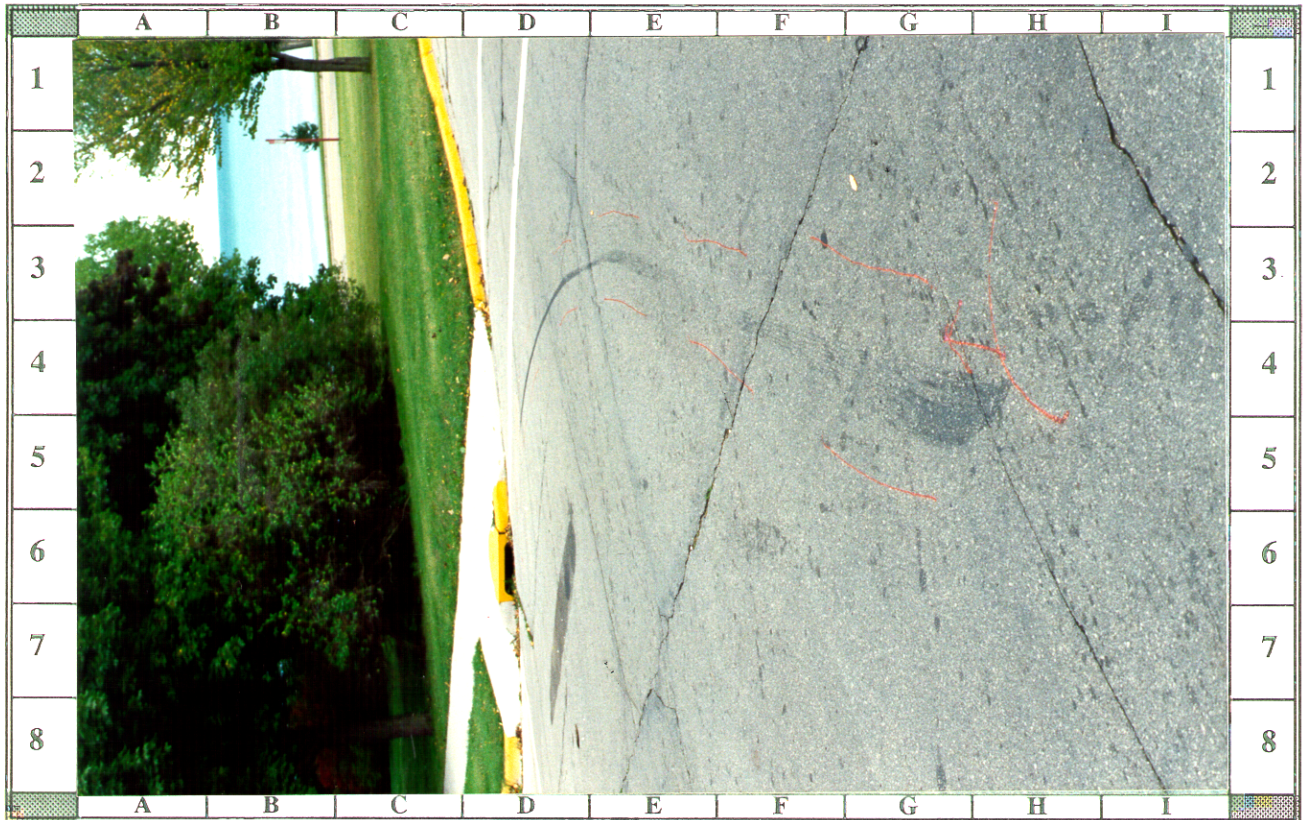
05 -- 1995 Plymouth Neon's southeastward, post-impact, travel path to spill (cells D6--D7) at final rest; NOTE: Omni's RF scuff

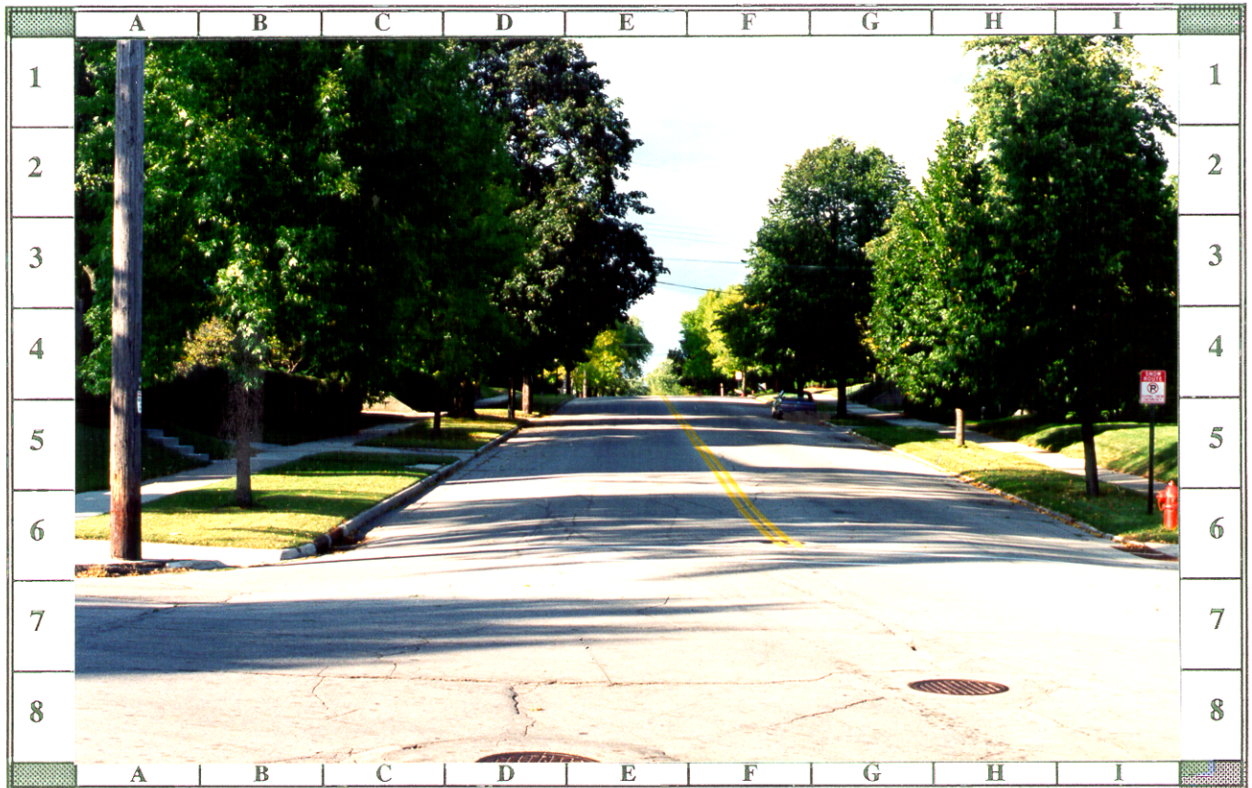
07 -- Northward view of 1995 Plymouth Neon's southward path of travel
from area of impact; NOTE: approach slope is approximately 4.7%

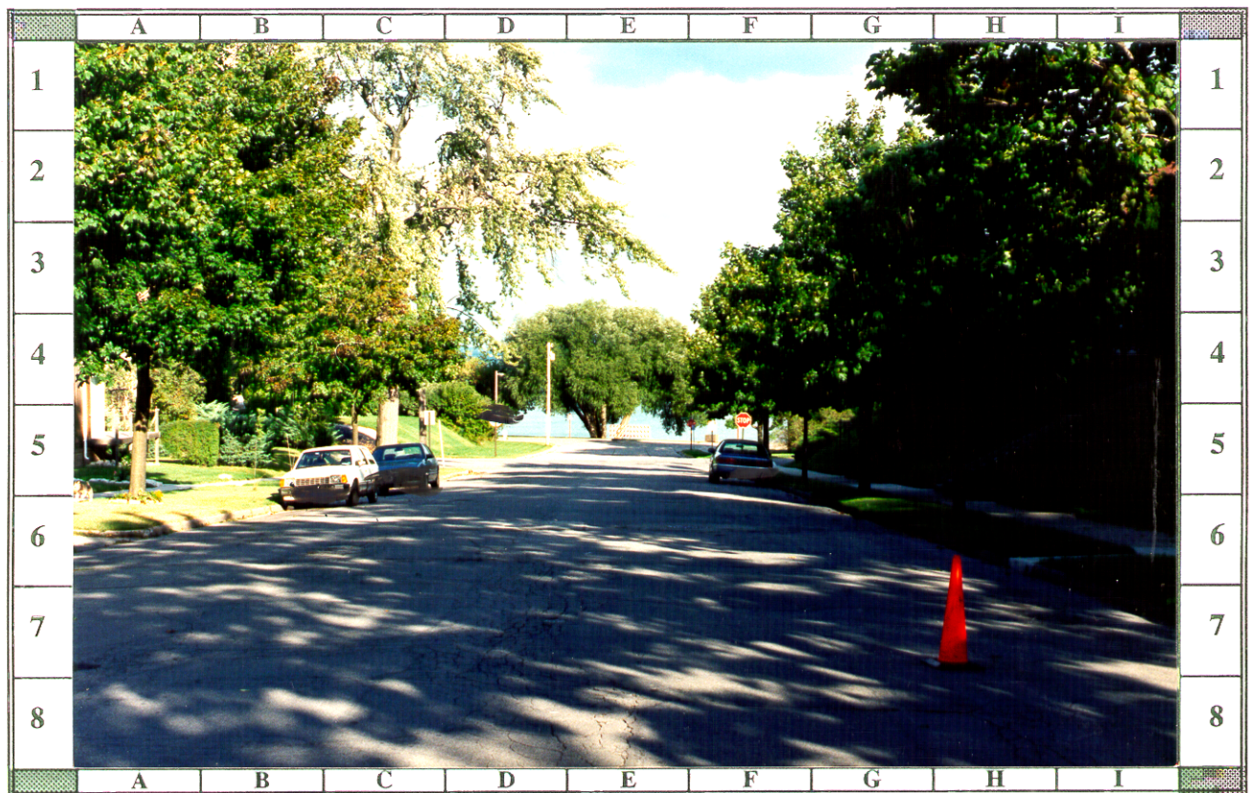
08 -- 1986 Dodge Omni's eastward downhill travel path approximately 65
meters west of intersection

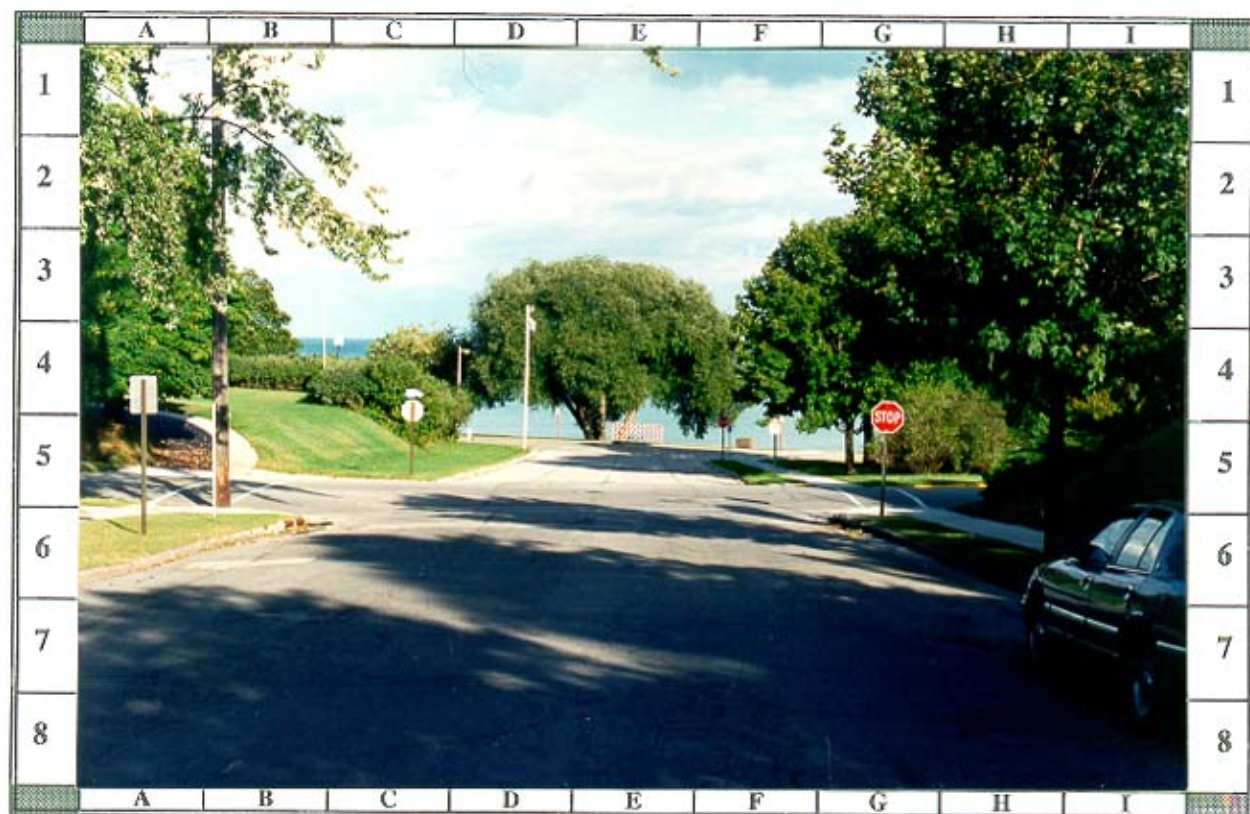
09 -- 1986 Dodge Omni's eastward downhill travel path approximately 25 meters west of intersection

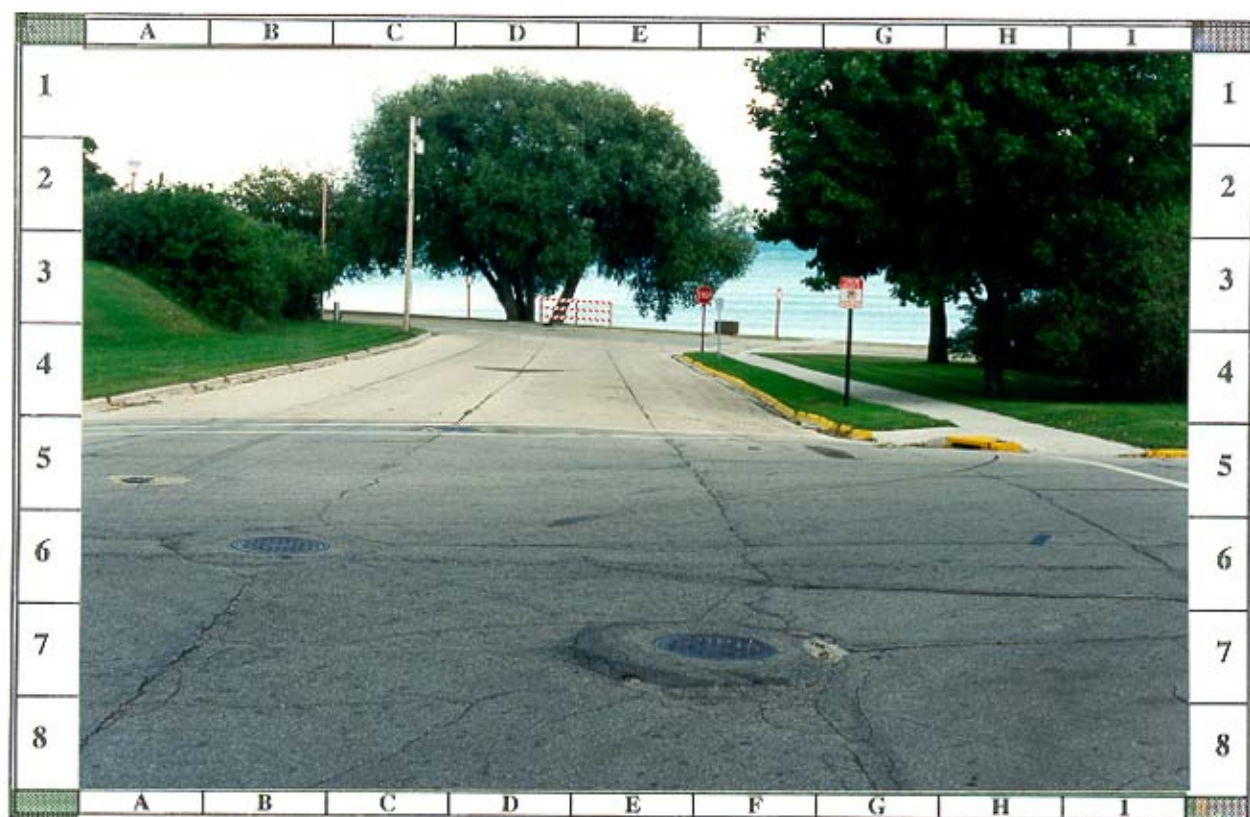
10 -- 1986 Dodge Omni's eastward downhill travel path approximately 5 meters west of intersection

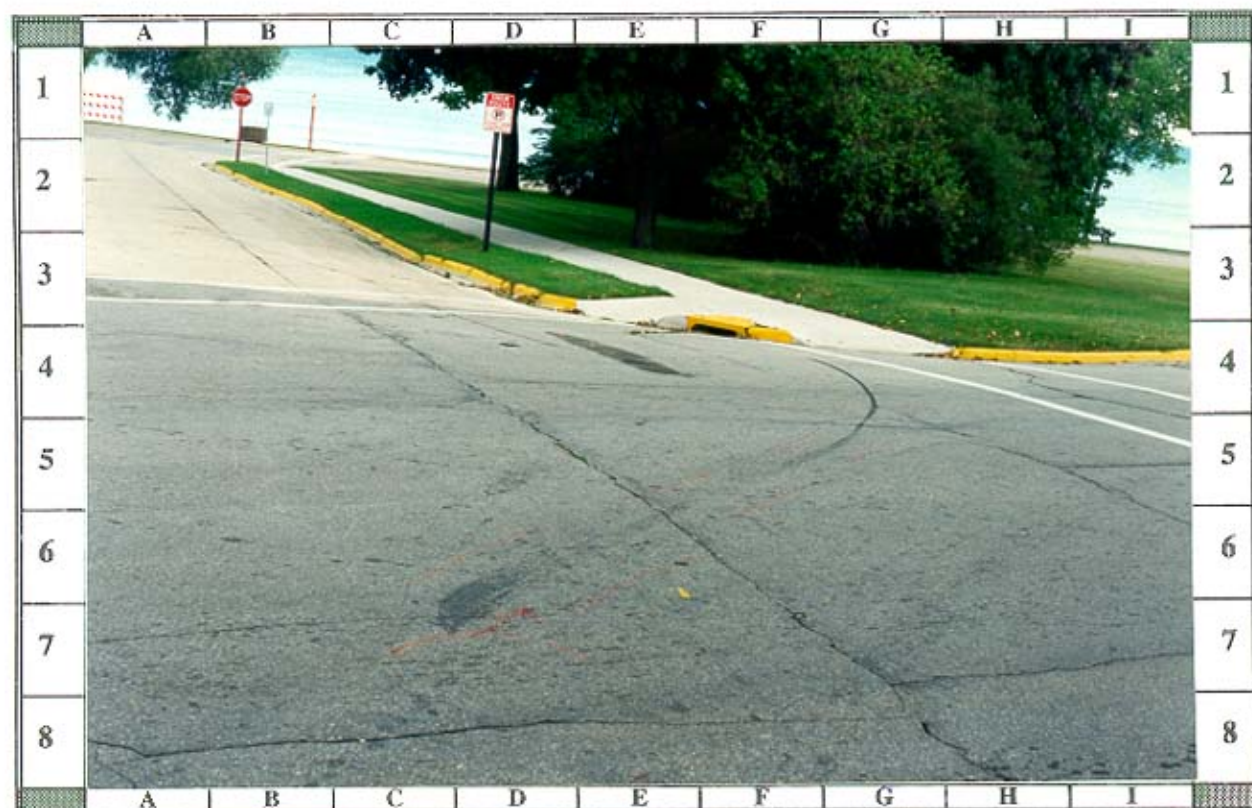
11 -- 1986 Dodge Omni's right front deflection/scuff mark post-impact looking east-southeast; NOTE: 1995 Neon's spill (cells D4--E4)

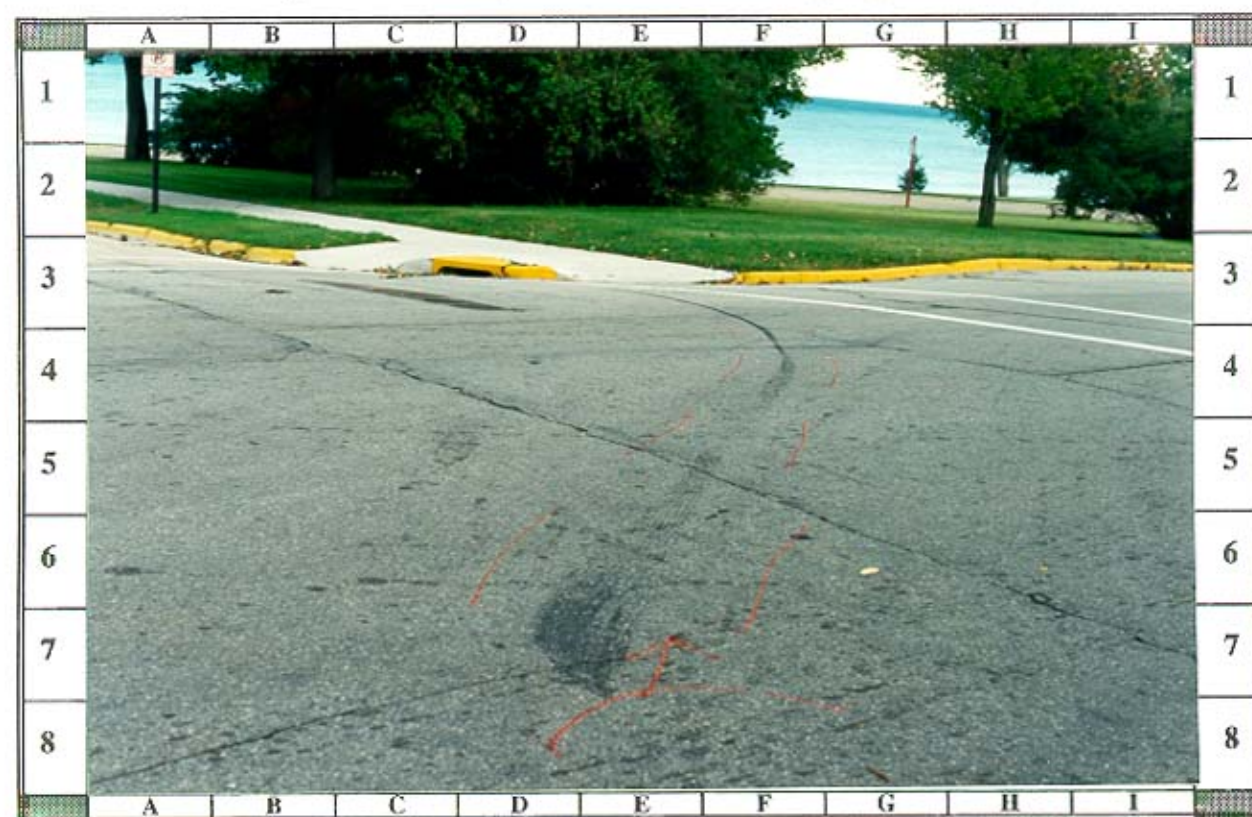
12 -- Close-up of 1986 Dodge Omni's right front deflection point & SE post-impact travel path; NOTE: 1995 Neon's spill (cells B3--D3)

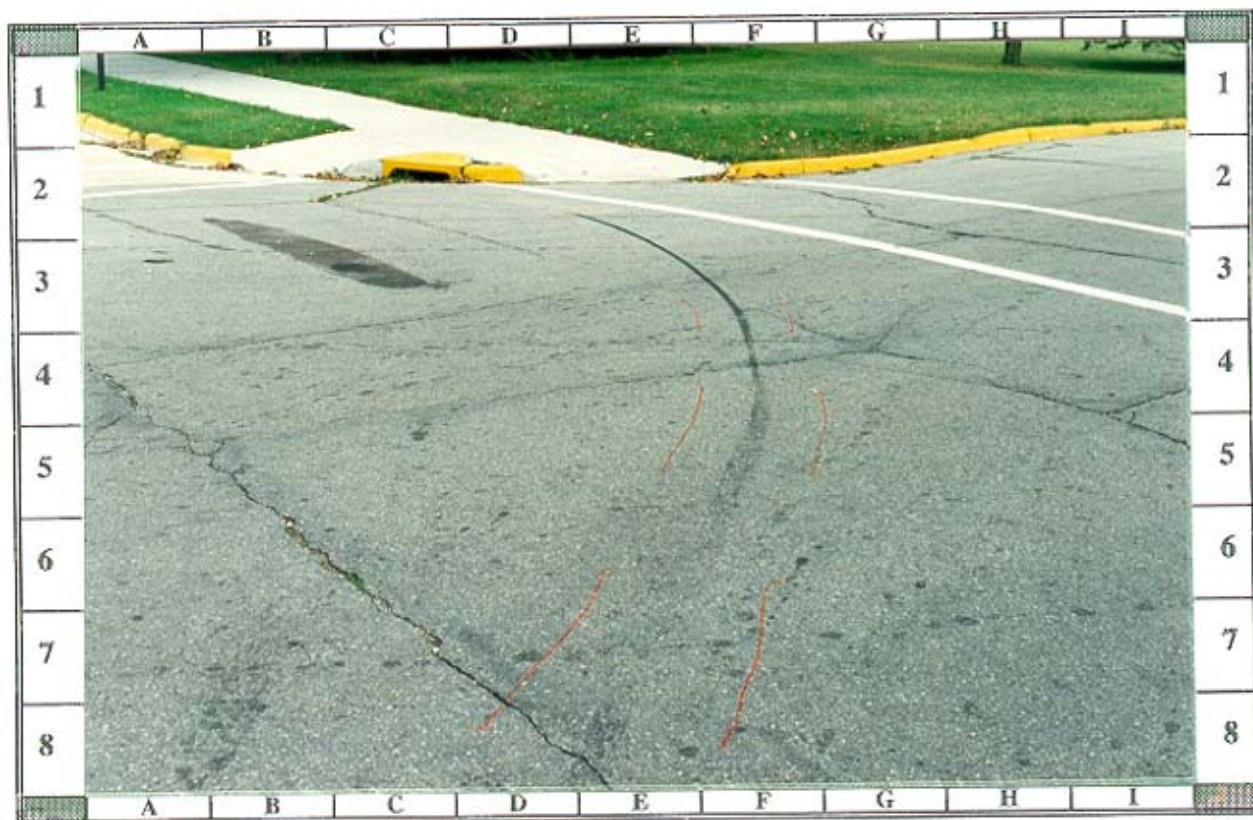
13 -- Close-up of 1986 Dodge Omni's right front scuff mark & southeast post-impact travel path; NOTE: 1995 Neon's spill (cells B2--C3)

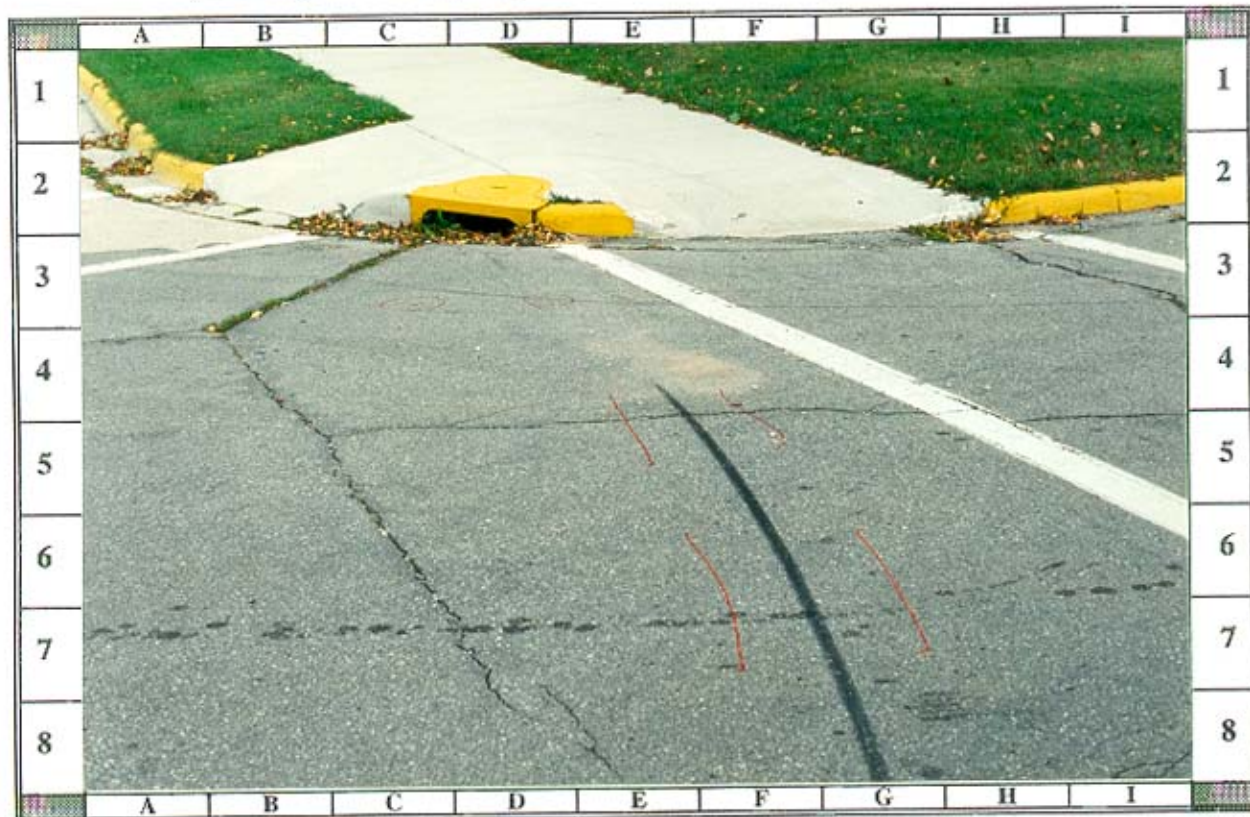
14 -- Close-up of end of 1986 Dodge Omni's right front scuff mark near final rest--looking east-southeast

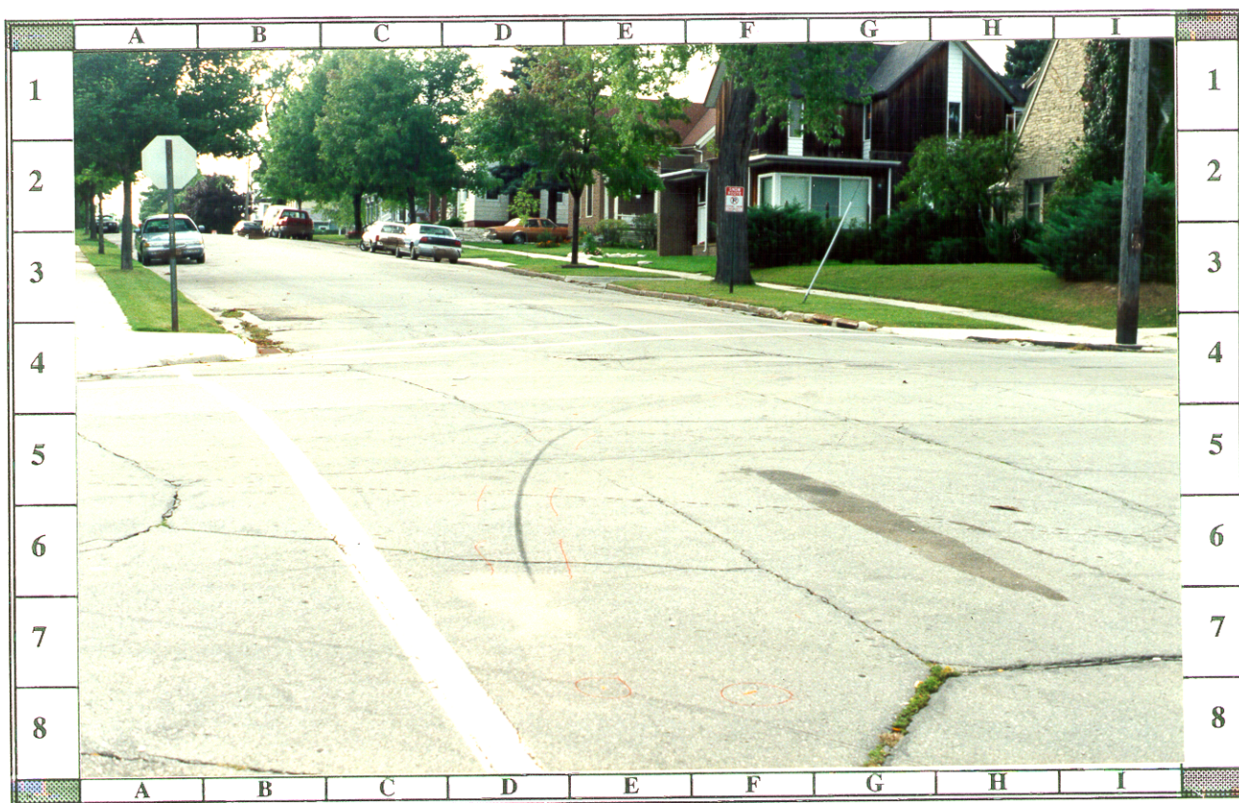
16 -- Westward view of 1986 Dodge Omni's eastward path of travel from area of final rest; NOTE: approach slope is approximately 9.0%

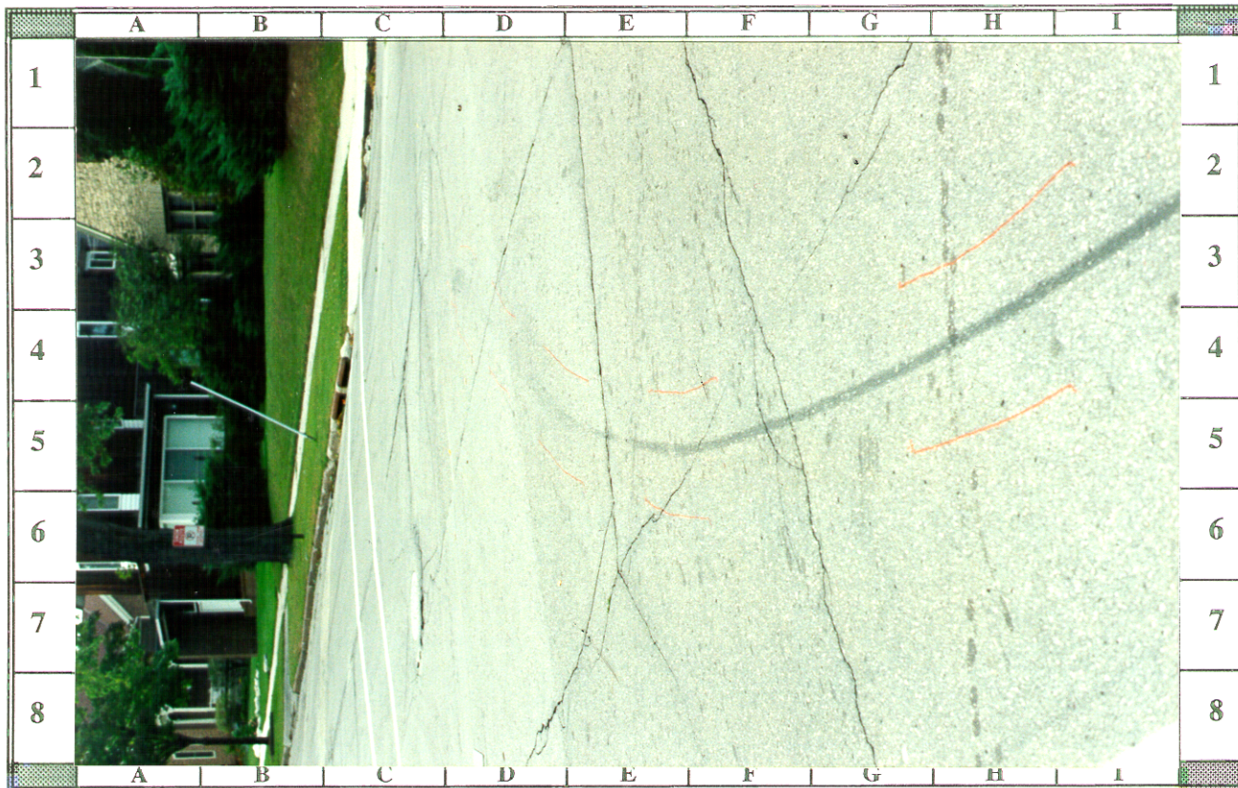
17 -- West-northwest view of 1986 Dodge Omni's right front scuff mark & southeast path from point of deflection (cell D3) toward rest

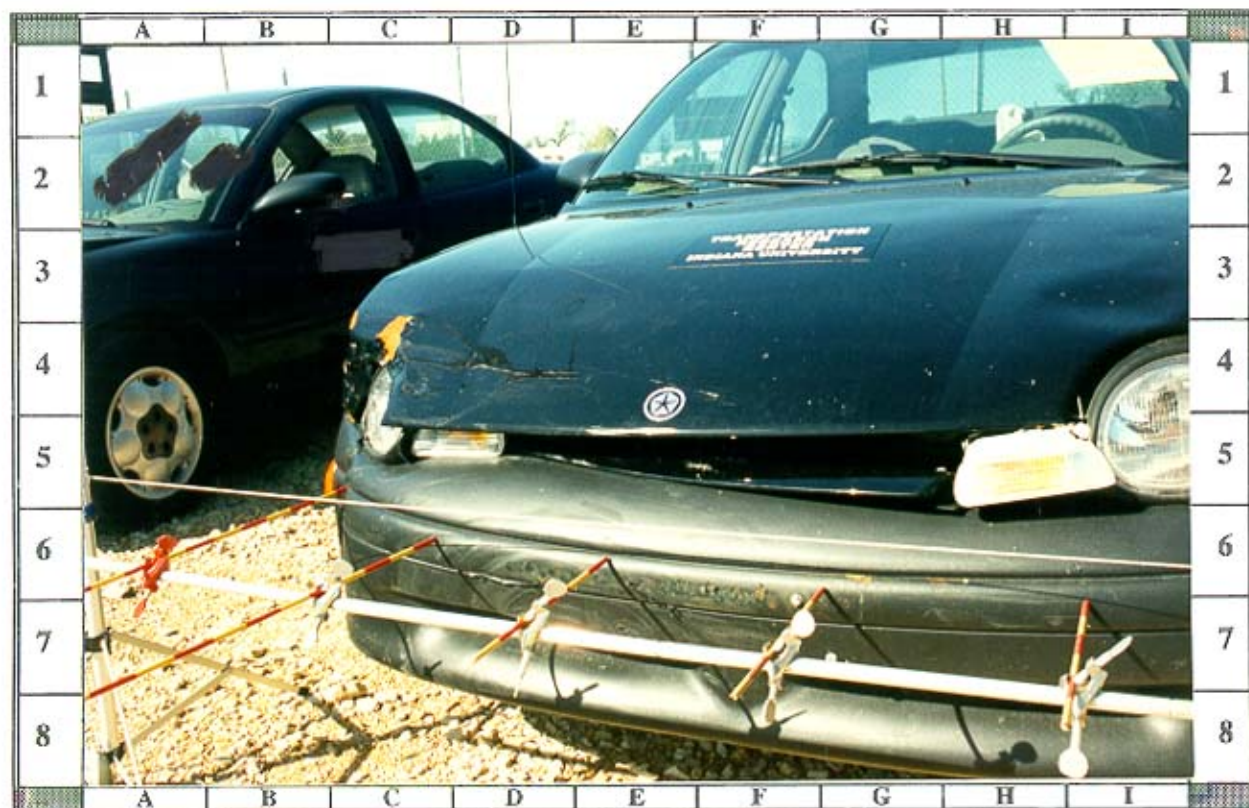
18 -- 1995 Plymouth Neon's frontal damage with contour guage present; viewed from front

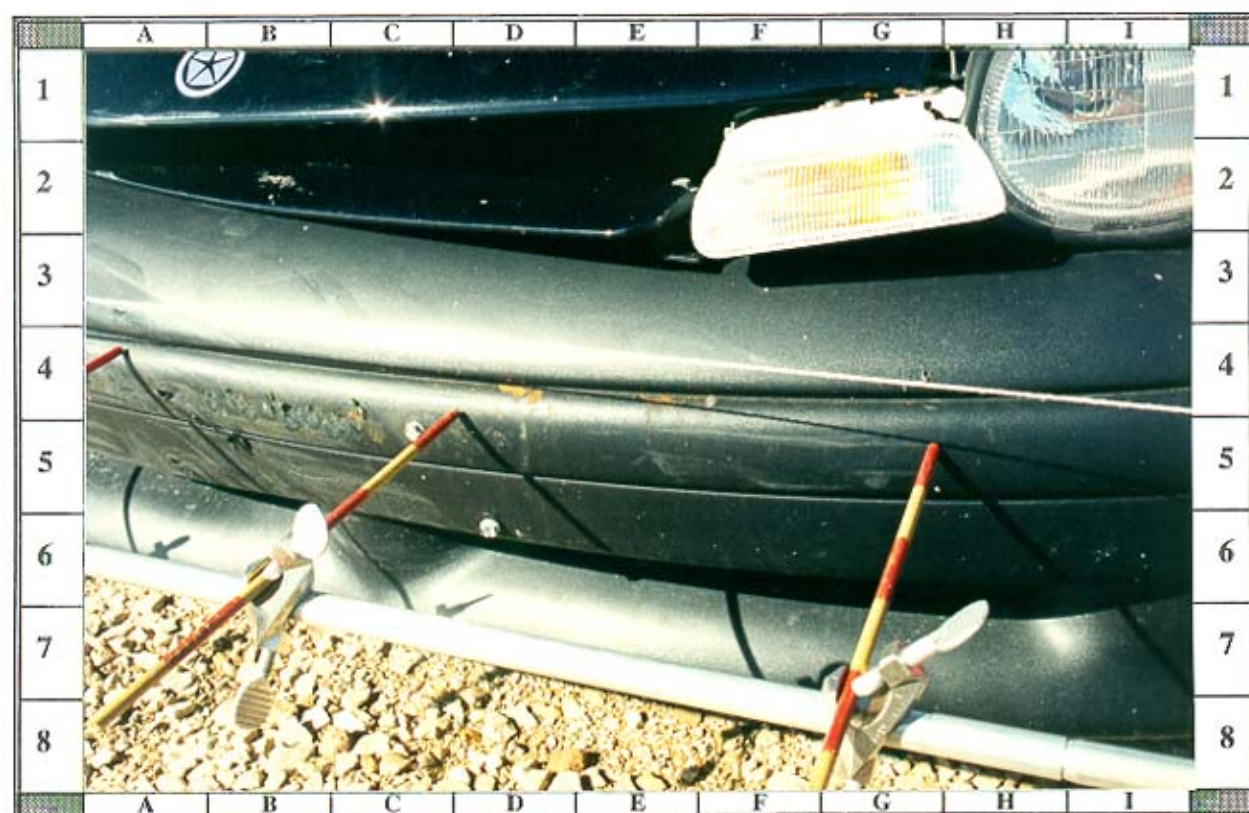
19 --- Close-up of direct damage to '95 Plymouth Neon's front bumper, hood, and right headlight assembly

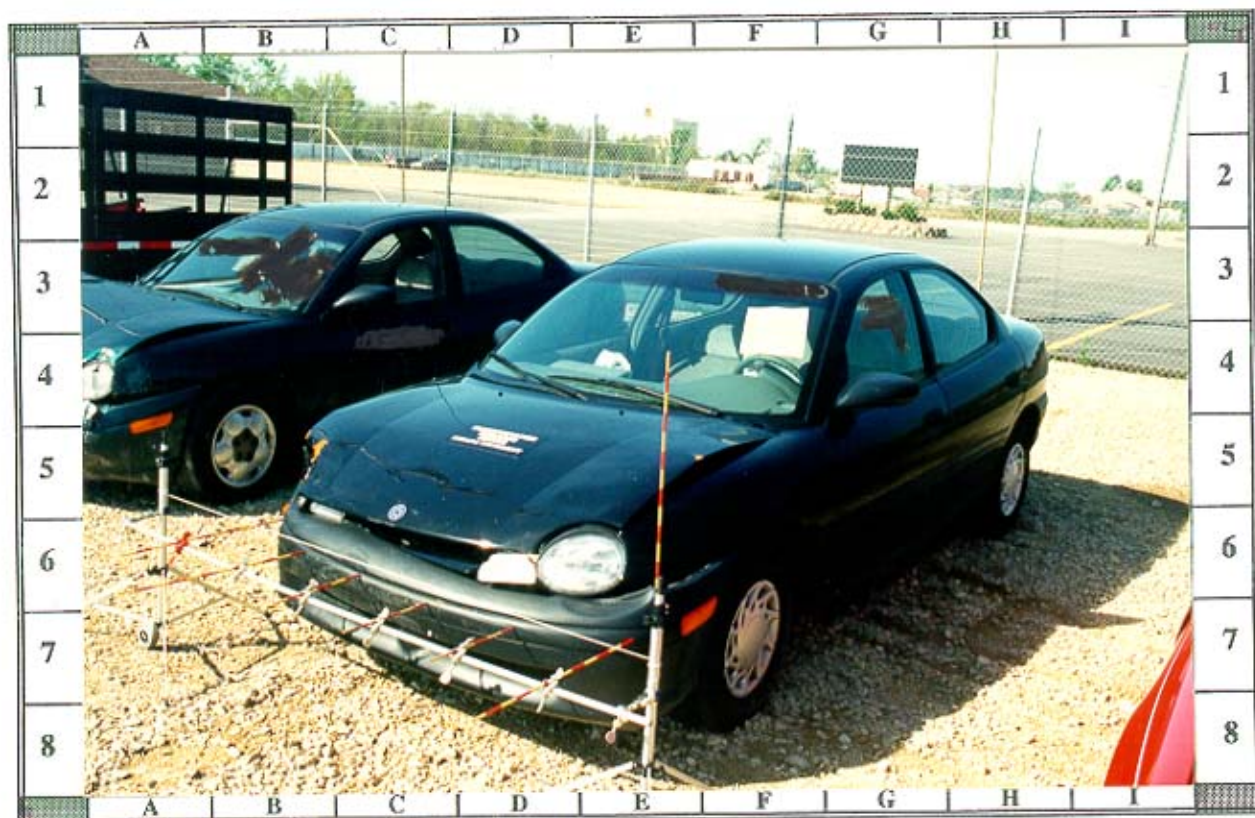
20 --- Closer-up of end of direct damage to 1995 Plymouth Neon's front bumper; NOTE: induced damage to left headlight assembly

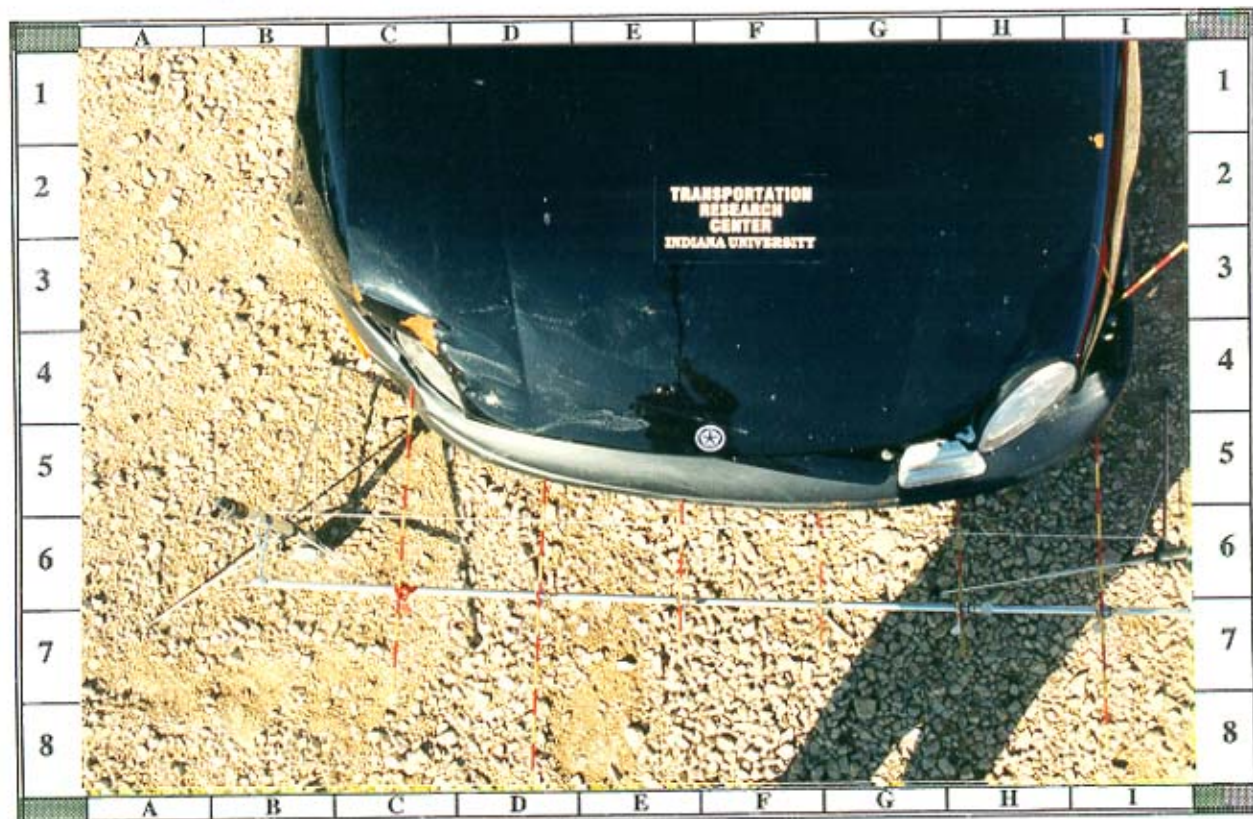
21 -- 1995 Plymouth Neon's frontal damage with contour gauge present; viewed from front left

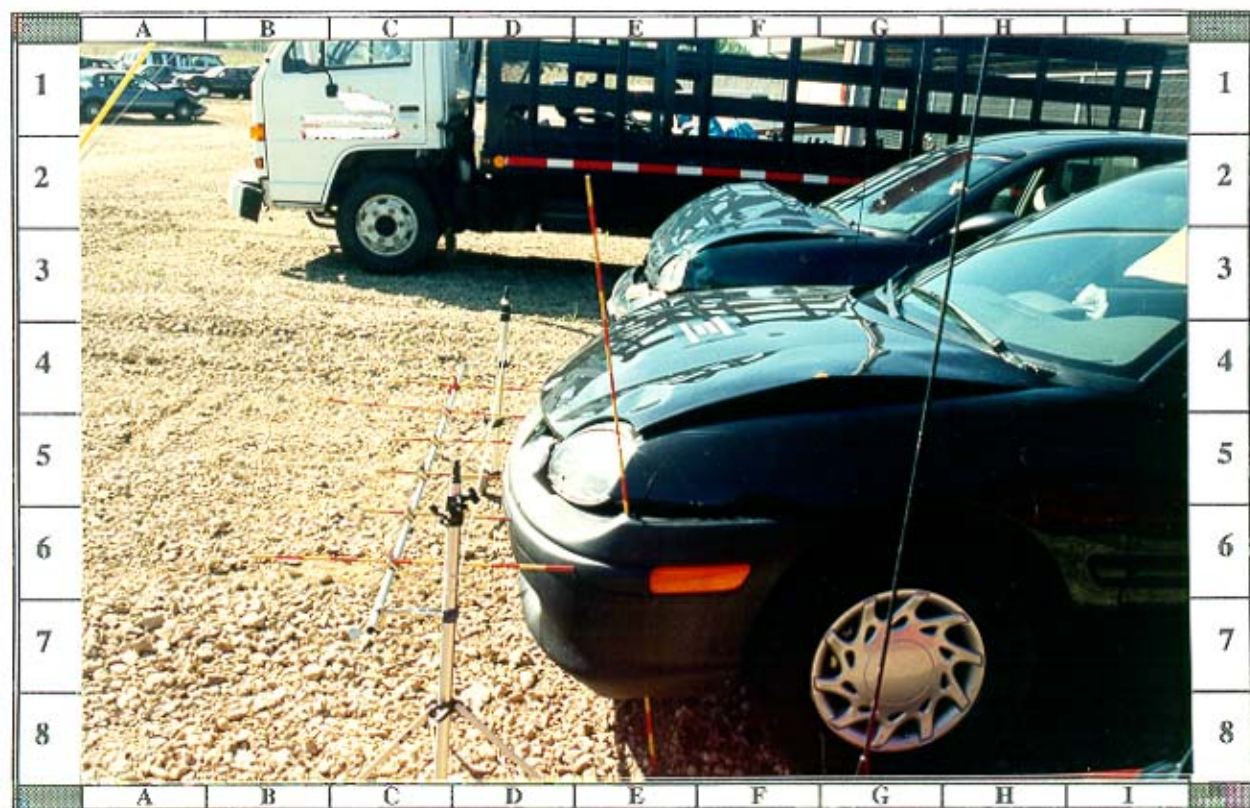
22 -- Overhead view of '95 Plymouth Neon's frontal damage with contour gauge present; viewed from front

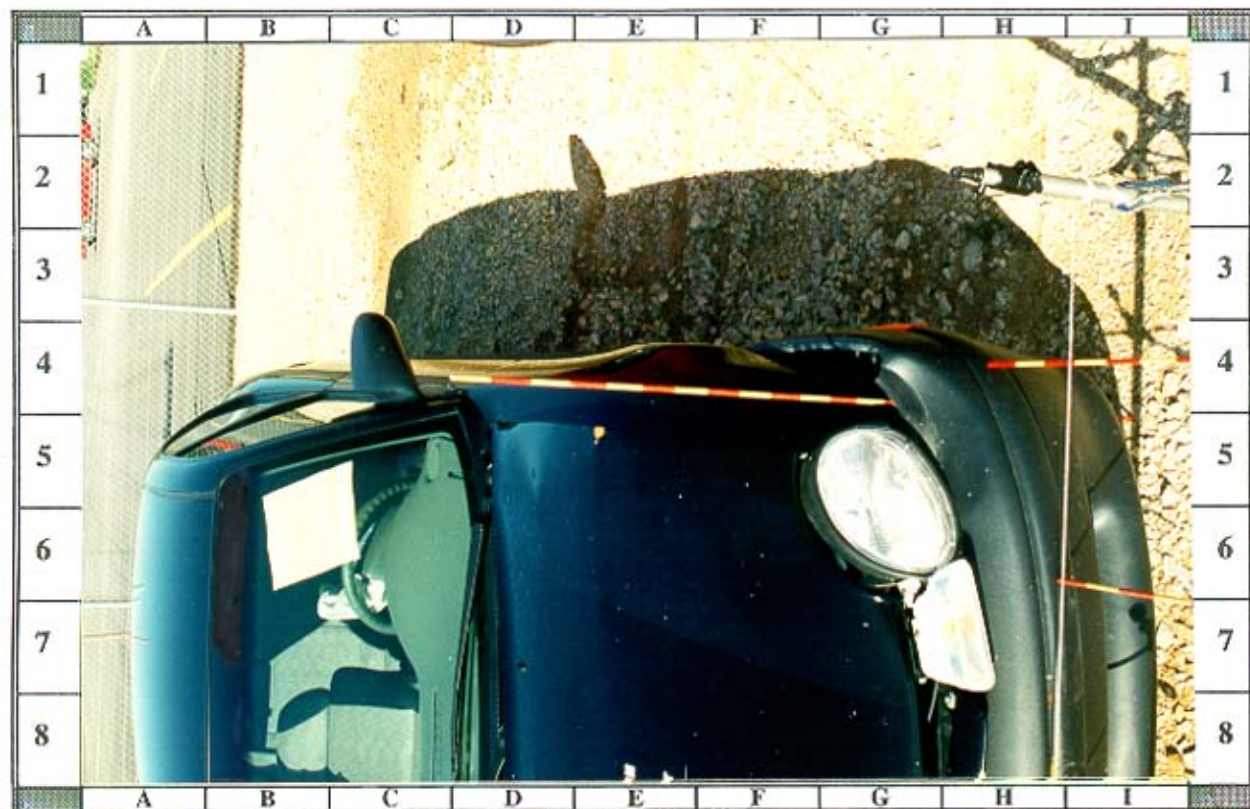
23 --- 1995 Plymouth Neon's frontal damage with contour guage present; viewed across front from left; NOTE: induced damage to hood

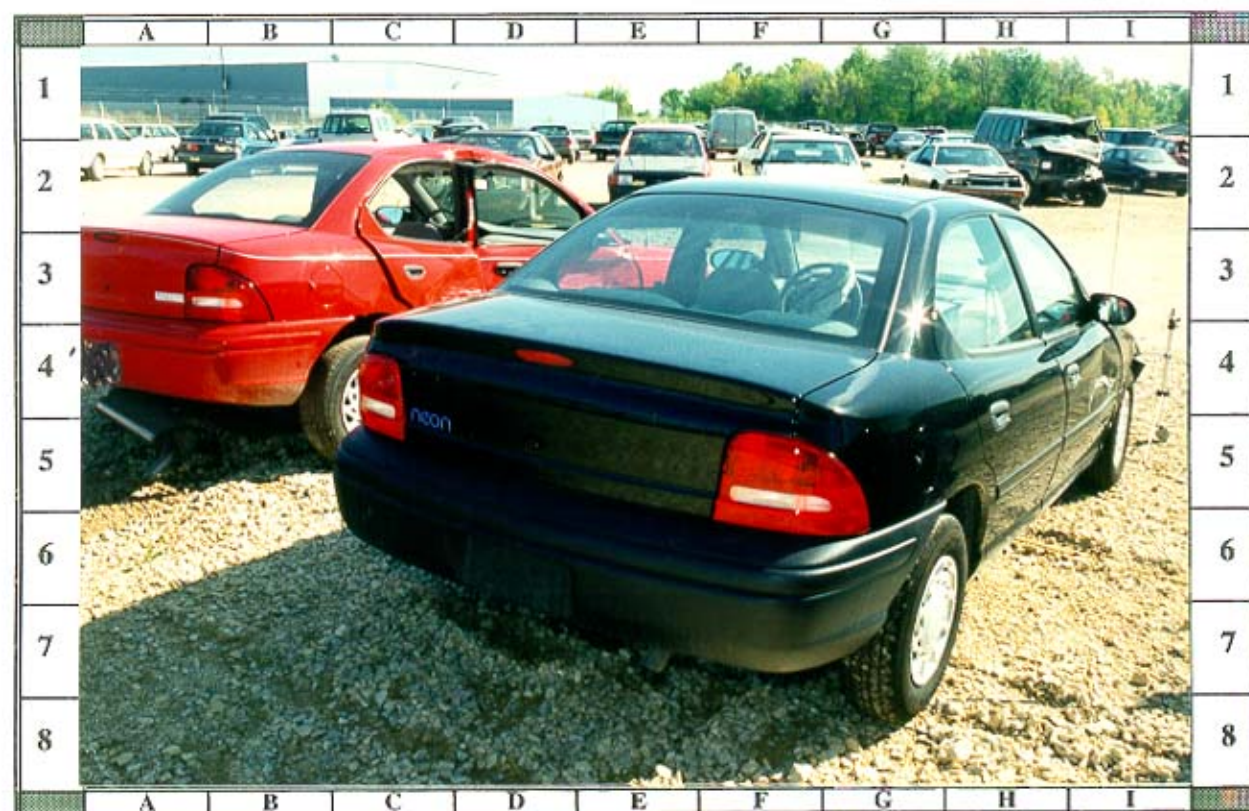
26 -- 1995 Plymouth Neon's undamaged rear & damaged right side viewed from rear right
